**Flood Control Project Maintenance  
Levee Inspections**

**Fall 2011 Levee Maintenance Deficiency Summary Report**

**Reclamation District No. 1500 Sutter Basin**

**Levee Inspection Report By Mile - Fall 2011**

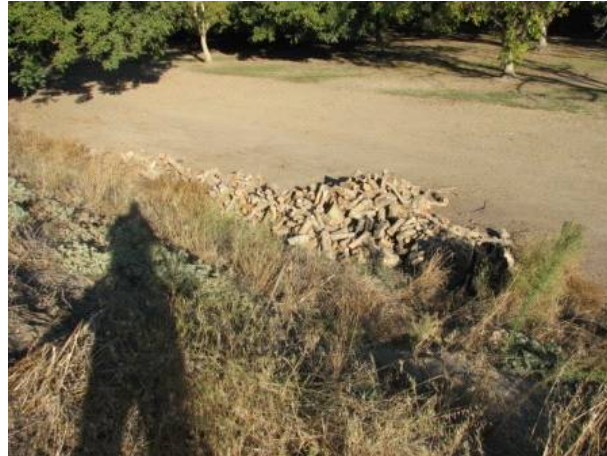
Levee Mile Report Line	1
Start Levee Mile	0.03
End Levee Mile	0.03
Location	Land Side
Category	Earthen Levee
Item	Encroachments
Fresh pile of firewood from this years prunings.	
johngw_f_20110923_394.jpg

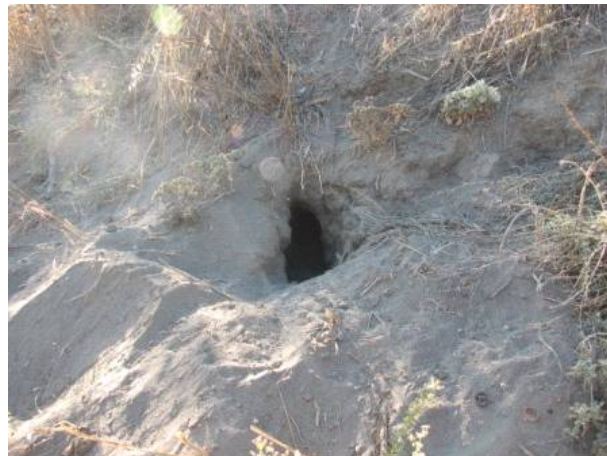
Levee Mile Report Line	2
Start Levee Mile	0.03
End Levee Mile	0.03
Location	Land Side
Category	Earthen Levee
Item	Animal Control
This is one of serval rodent holes in the area.	
johngw_f_20110923_399.jpg

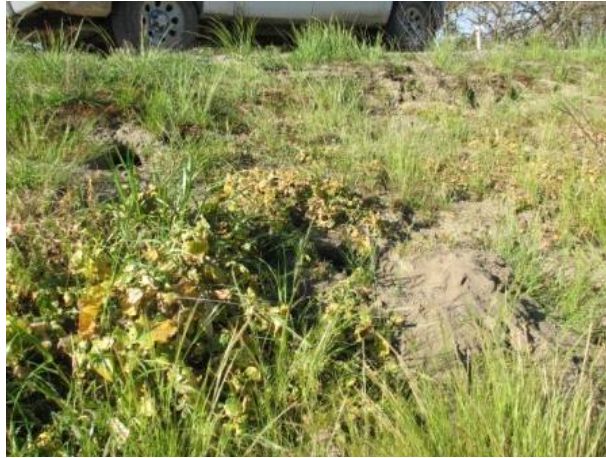
Levee Mile Report Line	2
Start Levee Mile	0.03
End Levee Mile	0.03
Location	Land Side
Category	Earthen Levee
Item	Animal Control

There are multiple rodents hole in the area.

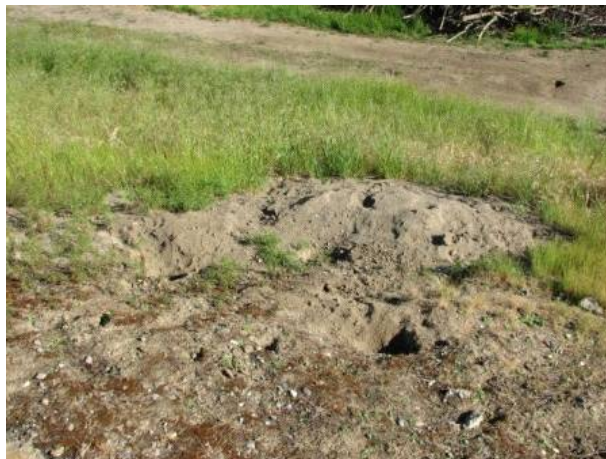
Levee Mile Report Line	2
Start Levee Mile	0.03
End Levee Mile	0.03
Location	Land Side
Category	Earthen Levee
Item	Animal Control

There are many rodent holes a short distance away from the last photo.

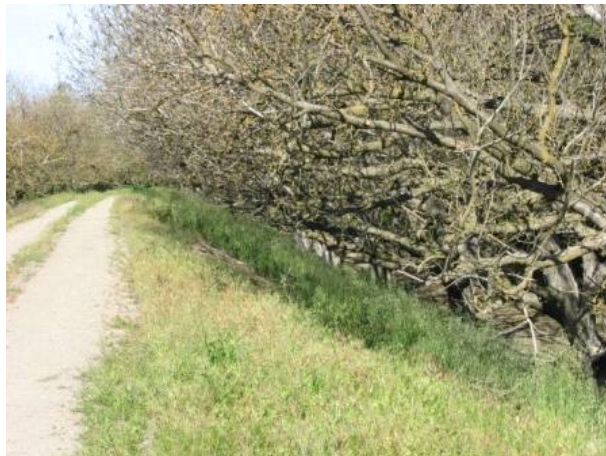
Levee Mile Report Line	3
Start Levee Mile	0.05
End Levee Mile	0.32
Location	Land Side
Category	Earthen Levee
Item	Trim / Thin Trees

The walnut trees need to be raised for visibility.

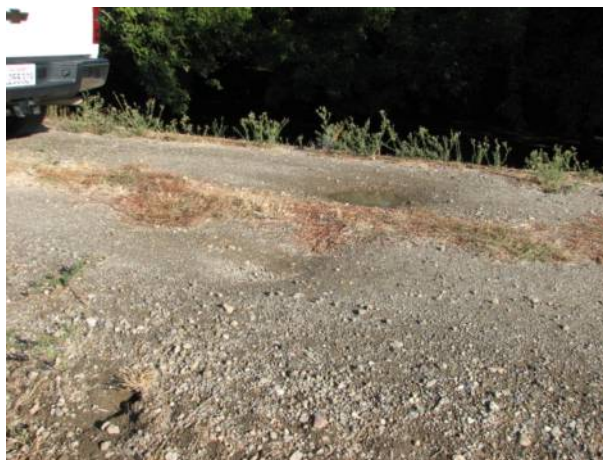
The depression appears to be in line with the rodent holes.

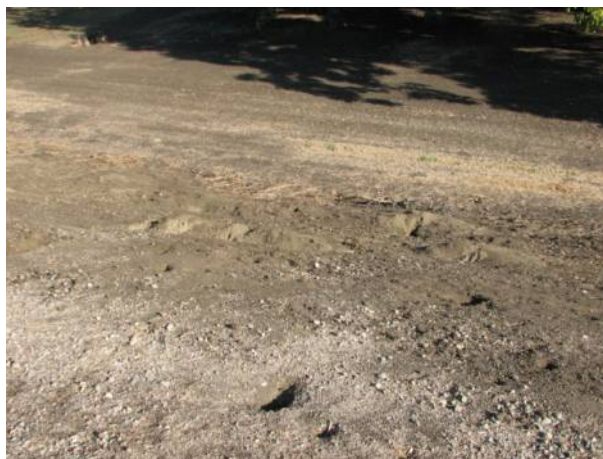
Levee Mile Report Line	8
Start Levee Mile	0.49
End Levee Mile	0.49
Location	Land Side
Category	Earthen Levee
Item	Animal Control

A series of rodent holes on the landside slope and toe of the levee.

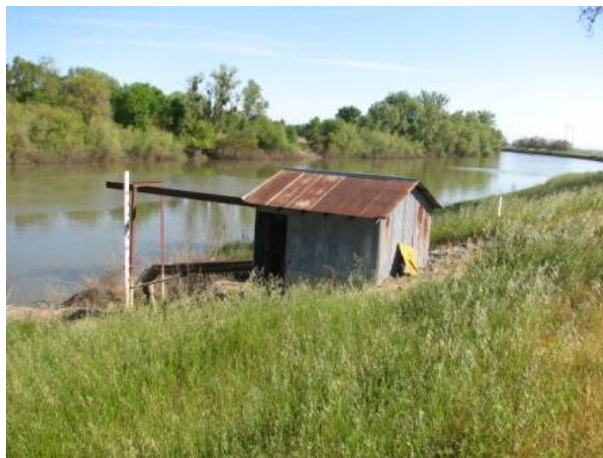
Levee Mile Report Line	10
Start Levee Mile	1.30
End Levee Mile	1.30
Location	Water Side
Category	Earthen Levee
Item	Encroachments

The building is of a pumphouse.

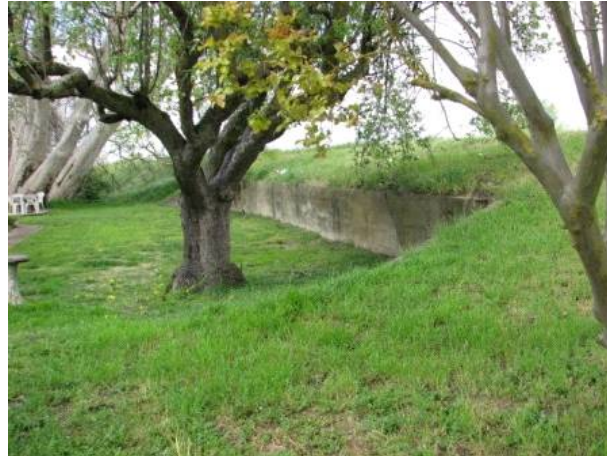
Levee Mile Report Line	12
Start Levee Mile	1.34
End Levee Mile	1.34
Location	Land Side
Category	Earthen Levee
Item	Encroachments
Landscape and retaining wall, this photo is from spring 2010.	
johngw_f_20110923_385.jpg

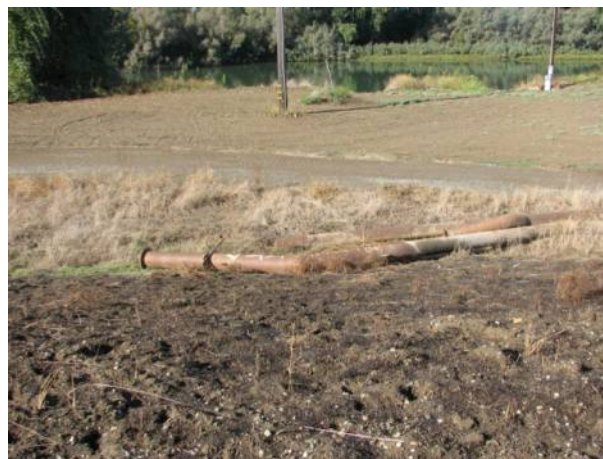
Levee Mile Report Line	14
Start Levee Mile	2.39
End Levee Mile	2.39
Location	Water Side
Category	Earthen Levee
Item	Encroachments

Old pipe left on the toe of the levee.

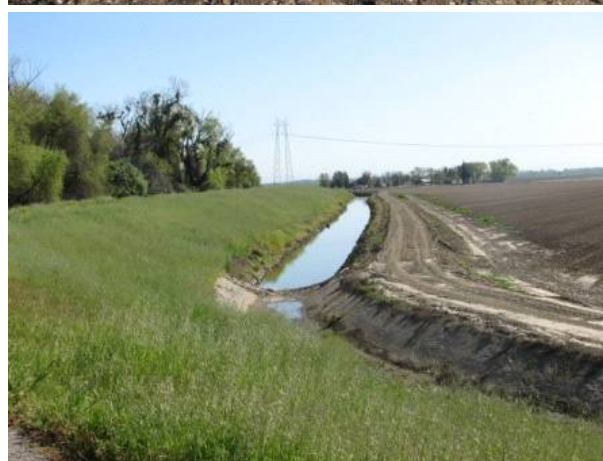
Levee Mile Report Line	15
Start Levee Mile	2.57
End Levee Mile	3.83
Location	Land Side
Category	Earthen Levee
Item	Encroachments

Agricultural ditch, photo was taken in spring 2010.

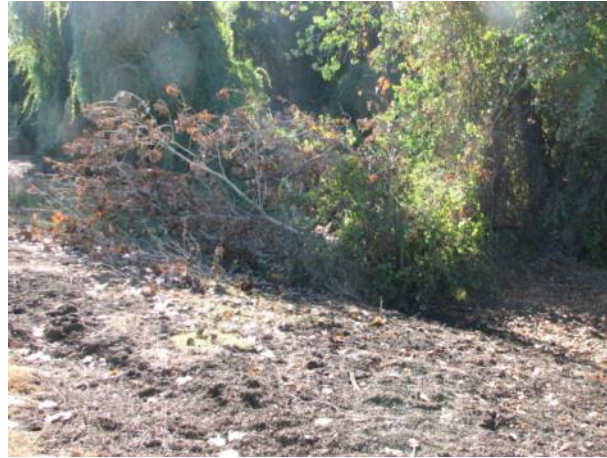
A large tree branch has fallen across the toe of the levee.

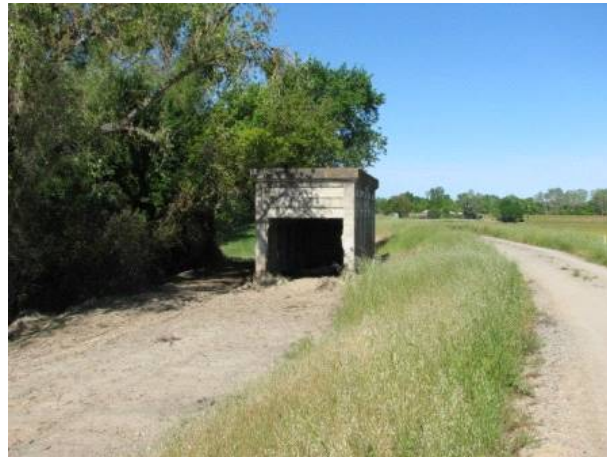
Levee Mile Report Line	17
Start Levee Mile	3.73
End Levee Mile	3.73
Location	Water Side
Category	Earthen Levee
Item	Encroachments

The photo is of the abandoned pumphouse. The district has placed a steel plate over the old outlets. They have began filling the structure for safety.

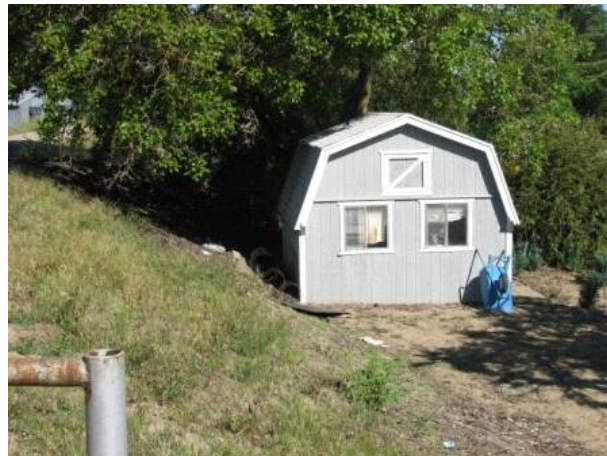
Levee Mile Report Line	18
Start Levee Mile	3.98
End Levee Mile	3.98
Location	Land Side
Category	Earthen Levee
Item	Encroachments

A small building is encroaching into the landside levee toe.

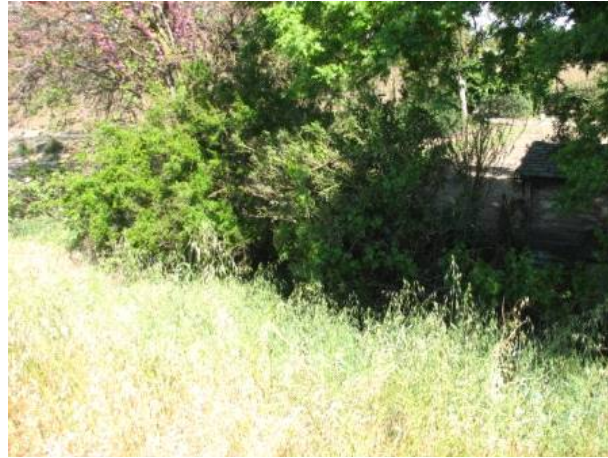
The landscape is planted within the encroachment area of 15'.

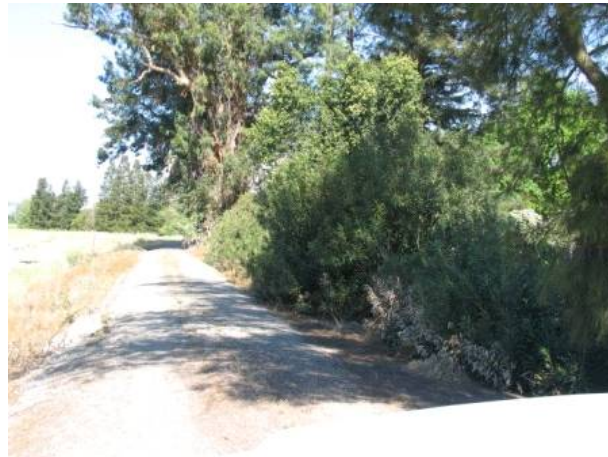
Levee Mile Report Line	25
Start Levee Mile	5.38
End Levee Mile	5.38
Location	Land Side
Category	Earthen Levee
Item	Encroachments

The landscape completely blocks the landside slope and toe.

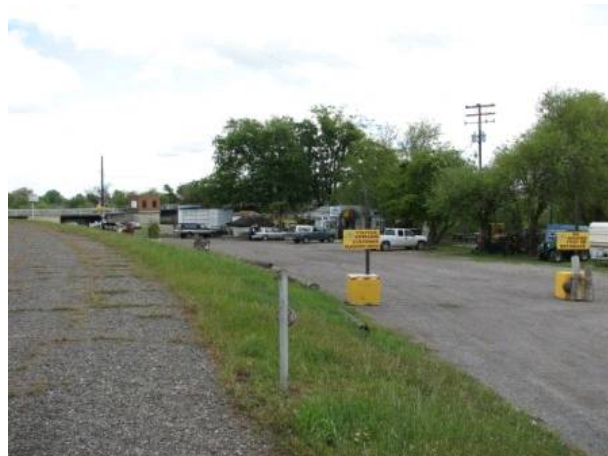
Levee Mile Report Line	26
Start Levee Mile	5.67
End Levee Mile	5.75
Location	Water Side
Category	Earthen Levee
Item	Encroachments

Sting Rays Marina RV park, Photo was taken in spring 2010.

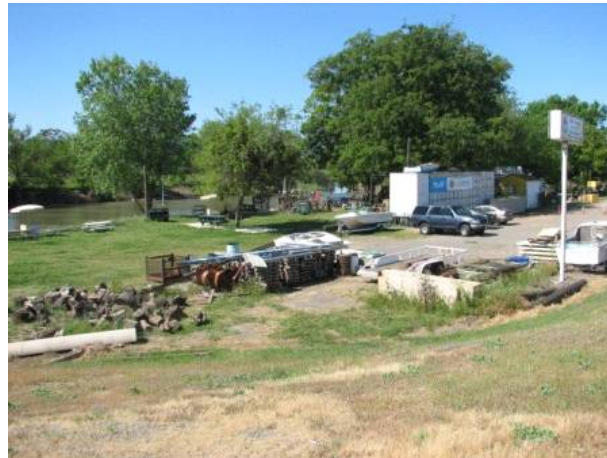
Here is another look at Sting Razs Marina and RV park

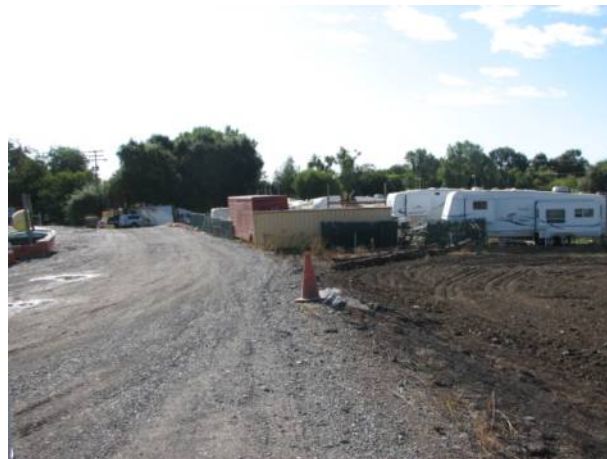
Levee Mile Report Line	26
Start Levee Mile	5.67
End Levee Mile	5.75
Location	Water Side
Category	Earthen Levee
Item	Encroachments

Another view of Stingraz's RV park and entrance to the waterside business.

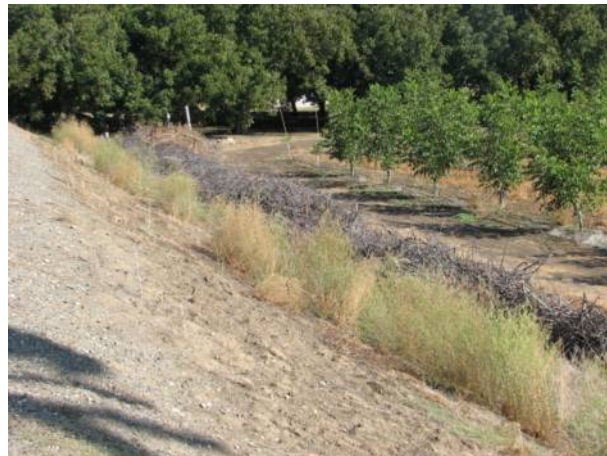
Levee Mile Report Line	27
Start Levee Mile	7.15
End Levee Mile	7.15
Location	Land Side
Category	Earthen Levee
Item	Encroachments

The land owner has piled prunings along the levee toe.

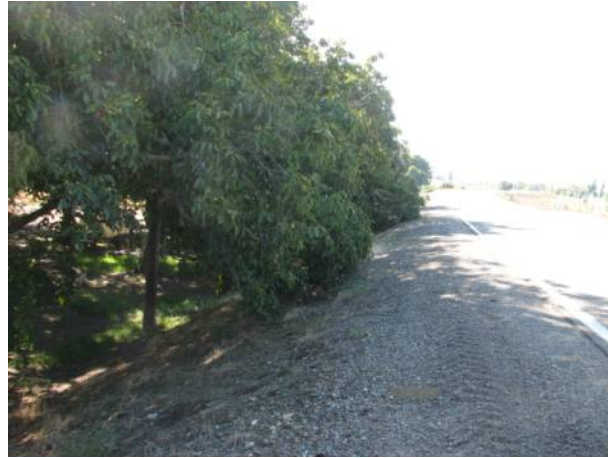
Trees need to be trimmed to the height of 5 feet to see the slope.

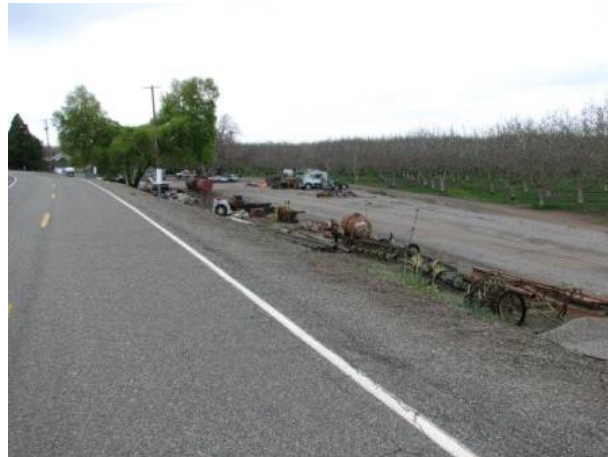
Levee Mile Report Line	29
Start Levee Mile	7.57
End Levee Mile	7.57
Location	Land Side
Category	Earthen Levee
Item	Encroachments

Equipment along landside toe. Photo was taken in spring 2010.

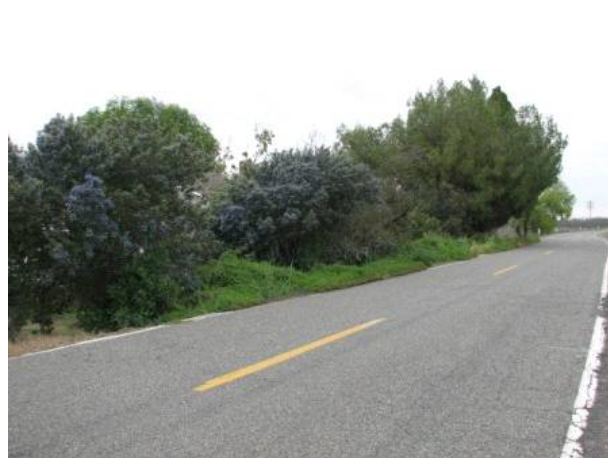
Levee Mile Report Line	30
Start Levee Mile	7.66
End Levee Mile	7.66
Location	Land Side
Category	Earthen Levee
Item	Encroachments

Landscape shrubs, photo taken in spring 2010.

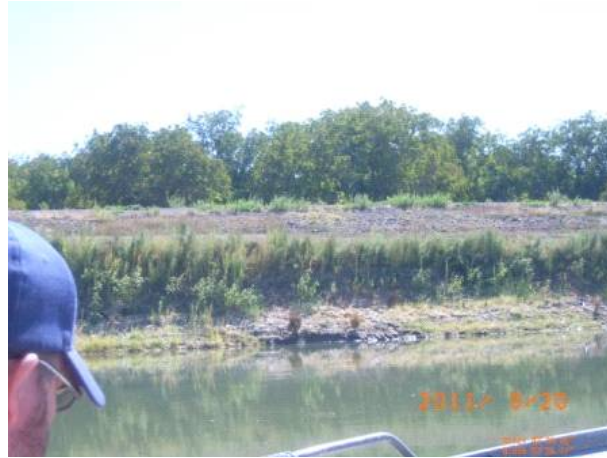
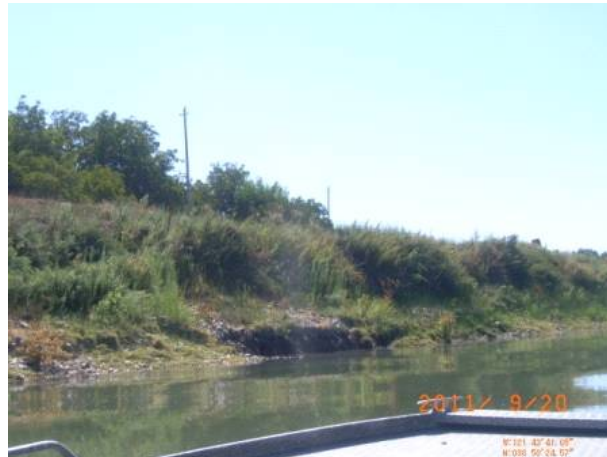
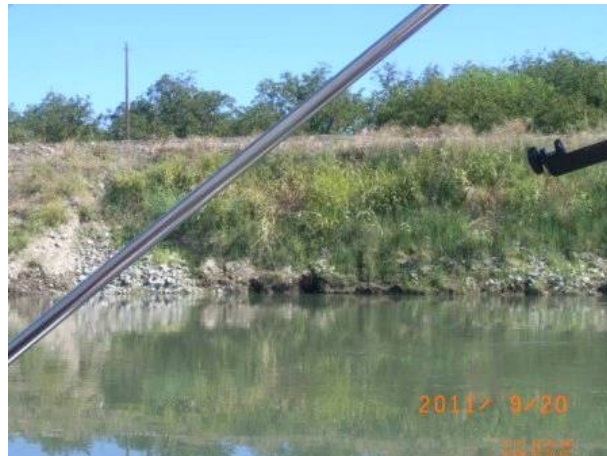
Levee Mile Report Line	31
Start Levee Mile	8.30
End Levee Mile	8.30
Location	Water Side
Category	Supplemental
Item	USACE Erosion Survey

LMR No.	Levee Mile		Category	Item	* Location	** Rating	Action/Comment	GPS Latitude/Longitude		Issue No.
	Start	End						Start	End	
31	8.30	8.30	Supplemental	USACE Erosion Survey	WS	M	Inspector Comments: 1997 - Damage to cobble revetment on top left bank and toe damage. 2004 - Site is pretty minor. 2010 - Cobbles continue to deteriorate. 2011: Minor new erosion at the toe. [2011 Site ID: SAC_92-8_L]	38.838464 ° -121.730205 °	38.840347 ° -121.726857 °	10 Y
32	8.43	8.43	Earthen Levee	Erosion / Bank Caving	LS	M	Schedule repair of erosion site prior to the next inspection.	38.839475 ° -121.728750 °	38.839475 ° -121.728750 °	56 Y
33	8.79	8.79	Earthen Levee	Encroachments	LS	PO	Buildings	38.842673 ° -121.726442 °	38.842673 ° -121.726442 °	18 Y
34	9.14	9.14	Earthen Levee	Crown Surface / Depressions / Rutting	CR	M	Regrade the crown roadway for proper drainage. Inspector Comments: This is a county road (Cranmore RD. ) on the crown. The county keeps adding asphalt to fill the depression.	38.847210 ° -121.727825 °	38.847210 ° -121.727825 °	221 Y

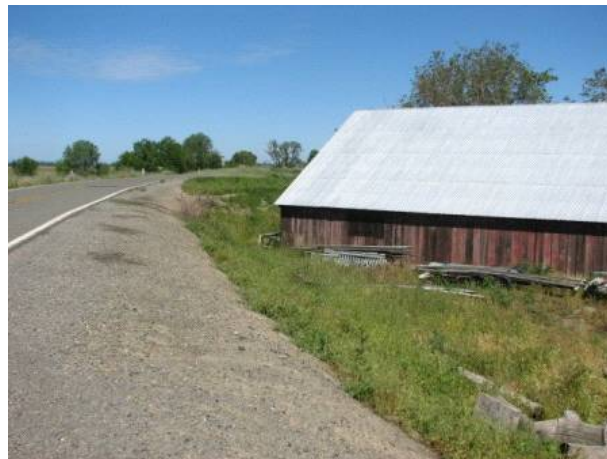
The corner of the building has encroached into the toe.

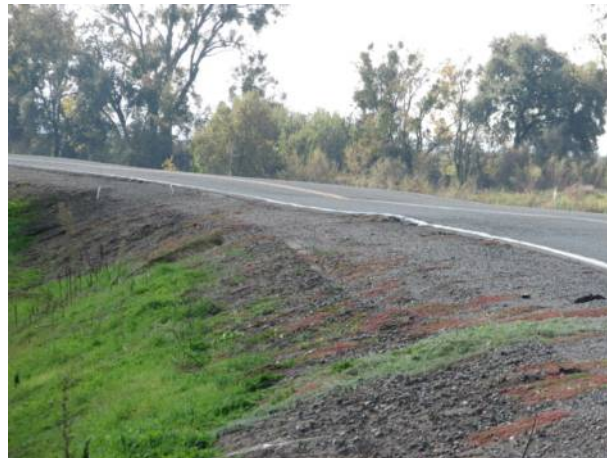
Levee Mile Report Line	34
Start Levee Mile	9.14
End Levee Mile	9.14
Location	Crown
Category	Earthen Levee
Item	Crown Surface / Depressions / Rutting

There is a depression in the county road that is on the crown. This has been an on going issue for years according to the district. Fall 2011

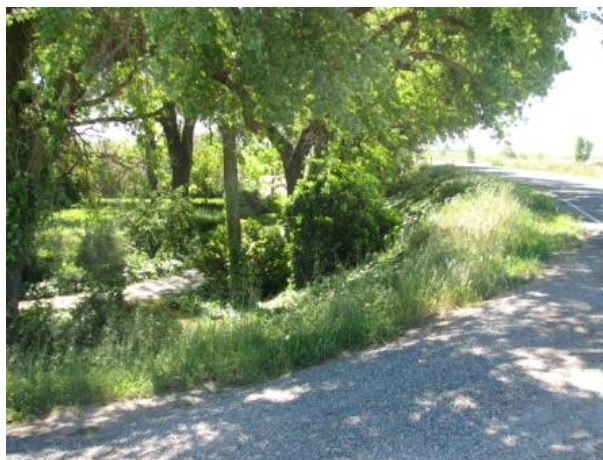
The homeowner has landscaped the levee slope.

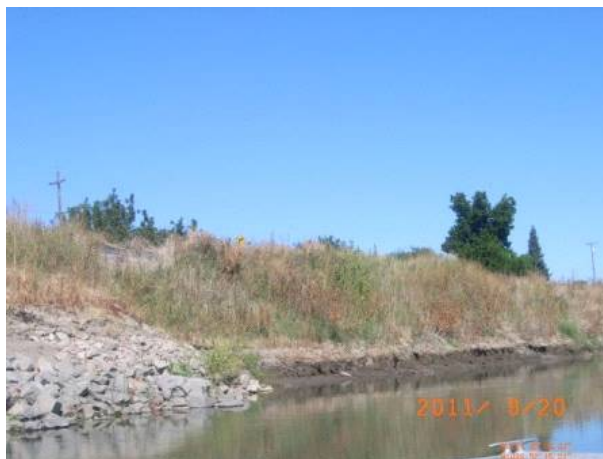
Levee Mile Report Line	36
Start Levee Mile	11.81
End Levee Mile	11.81
Location	Water Side
Category	Supplemental
Item	USACE Erosion Survey

35	11.43	11.43	Earthen Levee	Encroachments	LS	PO	Landscaping	38.866762 ° -121.746125 °	38.866762 ° -121.746125 °	20 Y
36	11.81	11.81	Supplemental	USACE Erosion Survey	WS	M	Inspector Comments: 1997 - No toe on the large upstream rubble (mix of broken concrete, bricks, rock, and steal) - should be replaced. Oversized bank. 2001 - New slump at the downstream end. 2003 - Some minor bank retreat at the downstream end. 2004 - Some new retreat at the downstream end. 2006 - Some new erosion, mainly on the steep slope and scarps. (Pumping station is not part of the erosion site.) 2010 - Minor new erosion. 2011: Minor new erosion at the toe. [2011 Site ID: SAC_95-8_L]	38.871853 ° -121.749330 °	38.870581 ° -121.752059 °	29 Y
37	11.93	11.93	Earthen Levee	Encroachments	WS	M	Debris	38.872220 ° -121.749785 °	38.872220 ° -121.749785 °	219 Y
38	11.93	11.93	Earthen Levee	Erosion / Bank Caving	WS	W	Note and monitor erosion site.	38.871972 ° -121.749765 °	38.871972 ° -121.749765 °	55

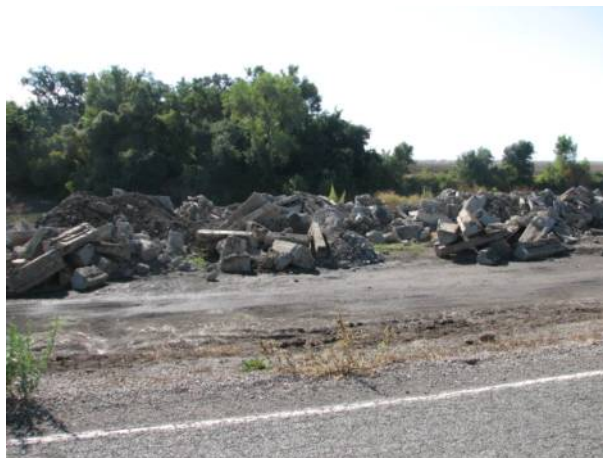
Levee Mile Report Line	37
Start Levee Mile	11.93
End Levee Mile	11.93
Location	Water Side
Category	Earthen Levee
Item	Encroachments

Concrete debris is being stockpiled on the slab of the old loading dock area.

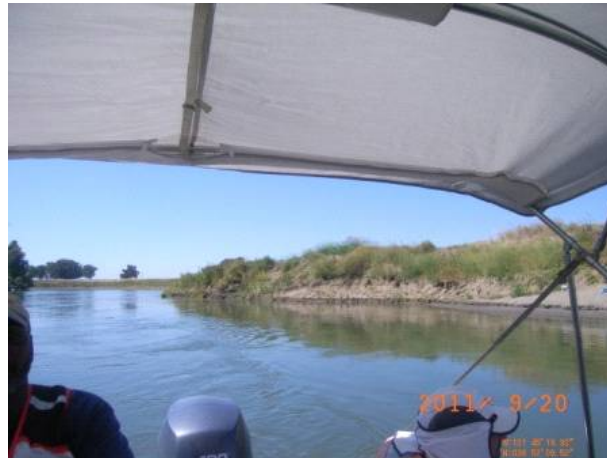
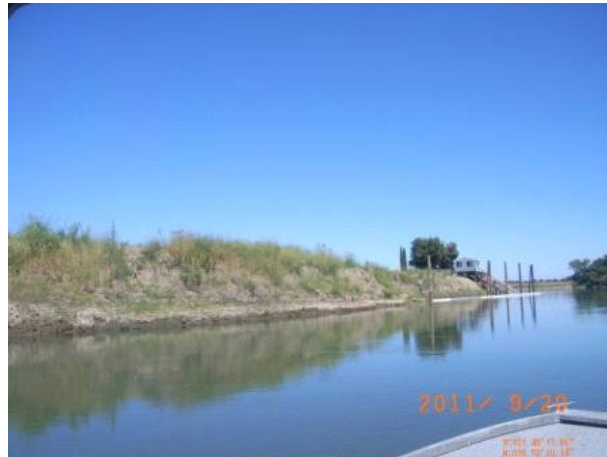
Levee Mile Report Line	39
Start Levee Mile	12.02
End Levee Mile	12.02
Location	Water Side
Category	Supplemental
Item	USACE Erosion Survey

39	12.02	12.02	Supplemental	USACE Erosion Survey	WS	M	Inspector Comments: 2000 - Vertical Modesto Formation bank with mass failure. 2003 - Upstream end has some new bank retreat. 2004 - Upstream end is worse. 2006 - Some new erosion, mainly on the steep slope and scarps. (Pumping station is not part of the erosion site.) 2010 - Some new erosion and deposition at upstream end, definite encroachments. 2011: Minor new erosion at the toe. [2011 Site ID: SAC_96-2_L]	38.870474 ° -121.752237 °	38.869139 ° -121.757108 °	34 Y
40	12.10	12.10	Earthen Levee	Encroachments	LS	M	Prunings	38.870920 ° -121.752417 °	38.870920 ° -121.752417 °	220 Y
41	12.15	12.15	Earthen Levee	Encroachments	WS	PO	Buildings	38.870562 ° -121.753335 °	38.870562 ° -121.753335 °	23 Y

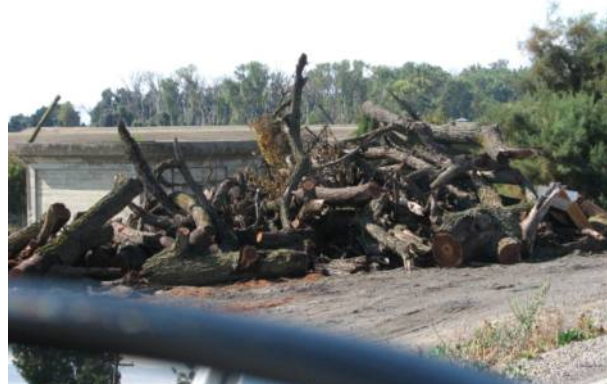
Levee Mile Report Line	40
Start Levee Mile	12.10
End Levee Mile	12.10
Location	Land Side
Category	Earthen Levee
Item	Encroachments

Trees have been removed and the wood and prunings are piled on the waterside berm.

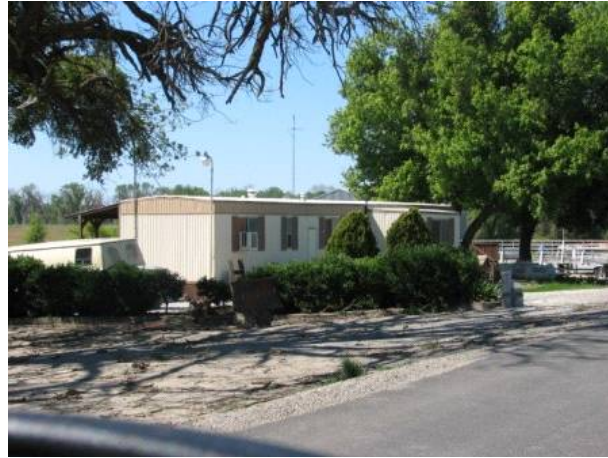
The mobile home is the home of the operator for Sutter Municiple Water.

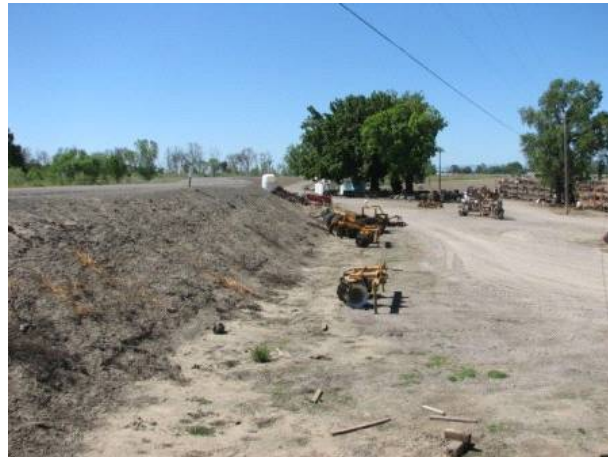
Levee Mile Report Line	43
Start Levee Mile	12.55
End Levee Mile	12.55
Location	Land Side
Category	Earthen Levee
Item	Encroachments

There is equipment parked along the toe of the levee.

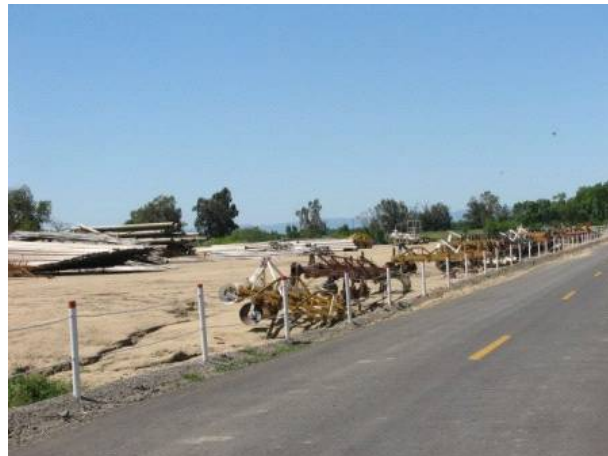
johngw\_f\_20110923\_407.jpg

On top of the crown is farm equipment and irrigation pipe.

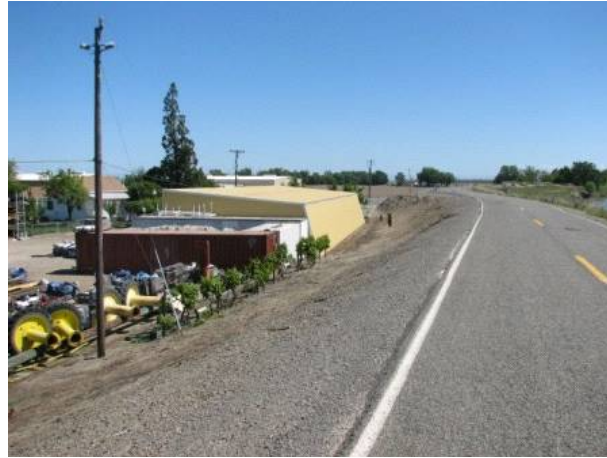
Levee Mile Report Line	45
Start Levee Mile	13.15
End Levee Mile	13.15
Location	Land Side
Category	Earthen Levee
Item	Encroachments
The buildings backside was built into the toe of the levee.	
johngw_f_20110923_408.jpg

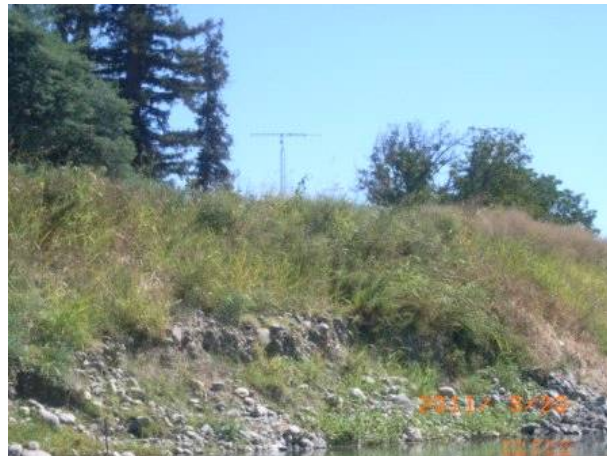
47	13.98	14.28	Supplemental	USACE Erosion Survey	WS	M	Inspector Comments: 1997 - Intermittent toe failure of the hand placed riprap; failure of toe materials. 2011: No observed change. [2011 Site ID: SAC_99-0_L]	38.857239 ° -121.783771 °	38.861899 ° -121.784057 °	40 Y
48	14.09	14.09	Earthen Levee	Encroachments	CR	M	Firewood	38.857683 ° -121.782652 °	38.857683 ° -121.782652 °	27 Y
49	14.13	14.13	Earthen Levee	Encroachments	WS	M	Equipment	38.857792 ° -121.783265 °	38.857792 ° -121.783265 °	28 Y
50	14.35	14.35	Earthen Levee	Encroachments	LS	CO	Buildings Inspector Comments: Concrete stemwall into levee embankment.	38.860848 ° -121.783307 °	38.860848 ° -121.783307 °	30 Y
51	14.39	14.39	Earthen Levee	Encroachments	LS	CO	Landscaping	38.861513 ° -121.783588 °	38.861513 ° -121.783588 °	31 Y
52	14.86	15.93	Earthen Levee	Encroachments	LS	PO	Agricultural Ditch	38.865473 ° -121.789413 °	38.871752 ° -121.804257 °	969 Y

Levee Mile Report Line	47
Start Levee Mile	13.98
End Levee Mile	14.28
Location	Water Side
Category	Supplemental
Item	USACE Erosion Survey
USACE 2011 Photo #1	
USACE2011_SAC_99-0_L_1.jpg

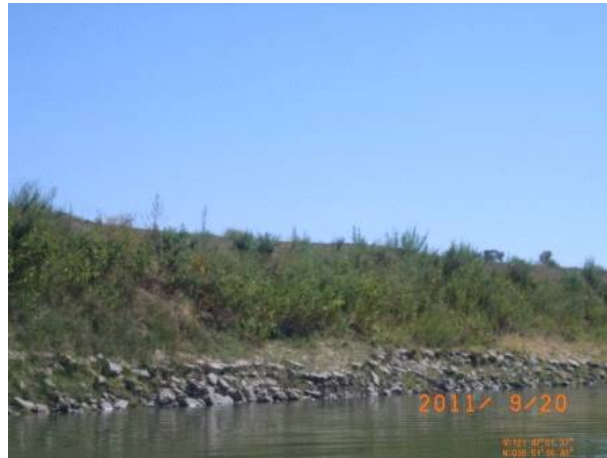
USACE 2011 Photo #2

Levee Mile Report Line	47
Start Levee Mile	13.98
End Levee Mile	14.28
Location	Water Side
Category	Supplemental
Item	USACE Erosion Survey

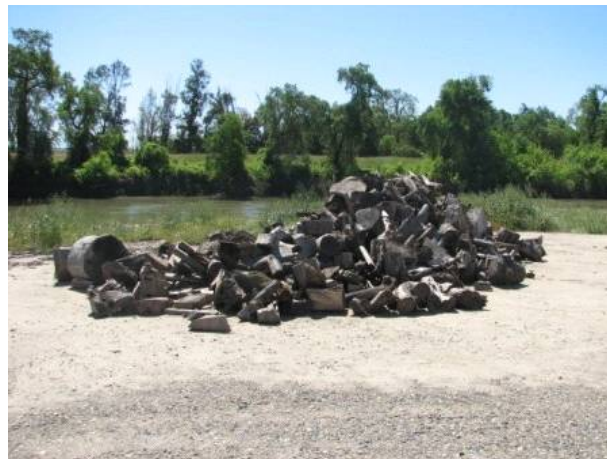
johngw\_f\_20110923\_409.jpg

Levee Mile Report Line	48
Start Levee Mile	14.09
End Levee Mile	14.09
Location	Crown
Category	Earthen Levee
Item	Encroachments

Firewood has been stacked on top of the levee crown.

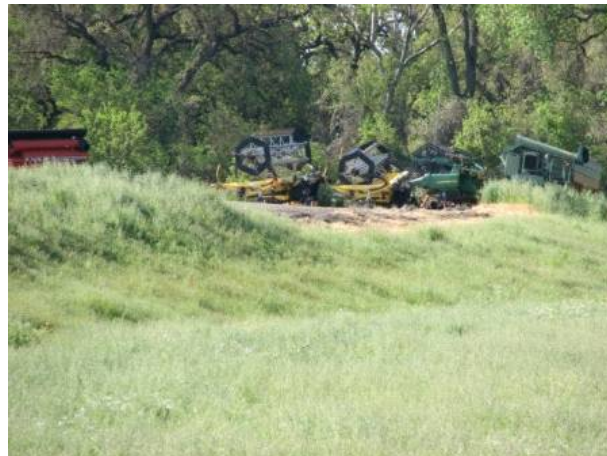
johngw\_f\_20110923\_410.jpg

Levee Mile Report Line	49
Start Levee Mile	14.13
End Levee Mile	14.13
Location	Water Side
Category	Earthen Levee
Item	Encroachments

View of equipment. Photo was taken in spring 2010.

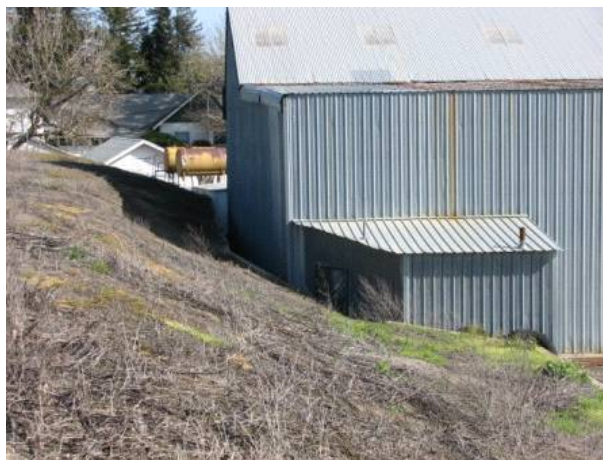
Levee Mile Report Line	50
Start Levee Mile	14.35
End Levee Mile	14.35
Location	Land Side
Category	Earthen Levee
Item	Encroachments
Building and wall into levee. Photo was taken in spring 2010.	
johngw_f_20110923_411.jpg

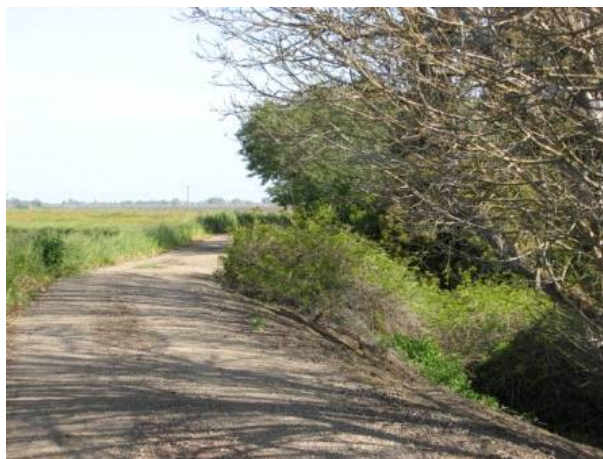
Levee Mile Report Line	51
Start Levee Mile	14.39
End Levee Mile	14.39
Location	Land Side
Category	Earthen Levee
Item	Encroachments
Landscape shrubs on shoulder. Photo was taken in spring 2010.	
johngw_f_20110923_412.jpg

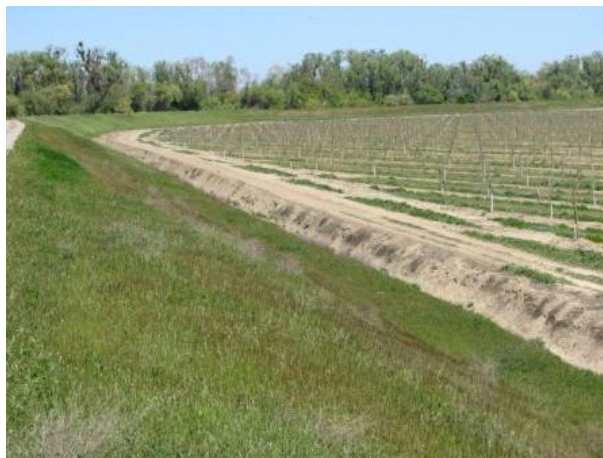
Levee Mile Report Line	52
Start Levee Mile	14.86
End Levee Mile	15.93
Location	Land Side
Category	Earthen Levee
Item	Encroachments
Agricultural ditch, photo taken in spring 2010.	
johngw_f_20110923_437.jpg

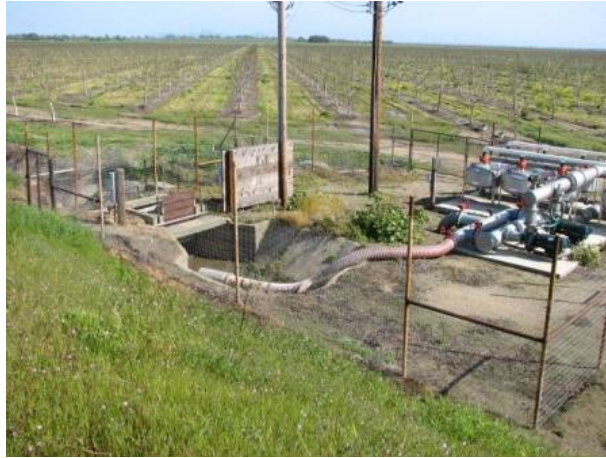
johngw\_f\_20110923\_404.jpg

Levee Mile Report Line	53
Start Levee Mile	15.27
End Levee Mile	15.27
Location	Land Side
Category	Earthen Levee
Item	Encroachments

Fence into levee toe, photo taken in spring 2010.

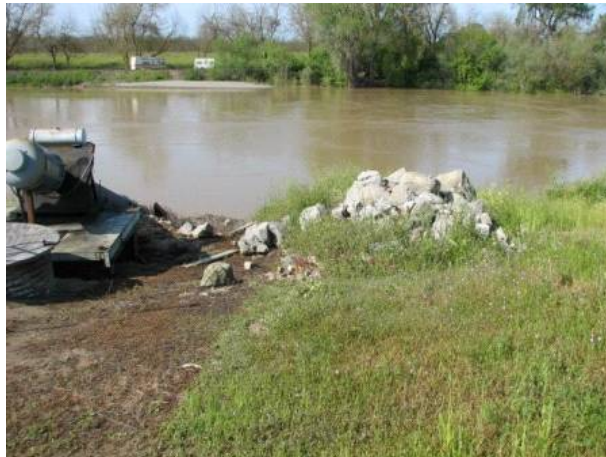
johngw\_f\_20110923\_403.jpg

Levee Mile Report Line	54
Start Levee Mile	15.27
End Levee Mile	15.27
Location	Water Side
Category	Earthen Levee
Item	Encroachments

Rip rap and concrete debris, photo taken in spring 2010.

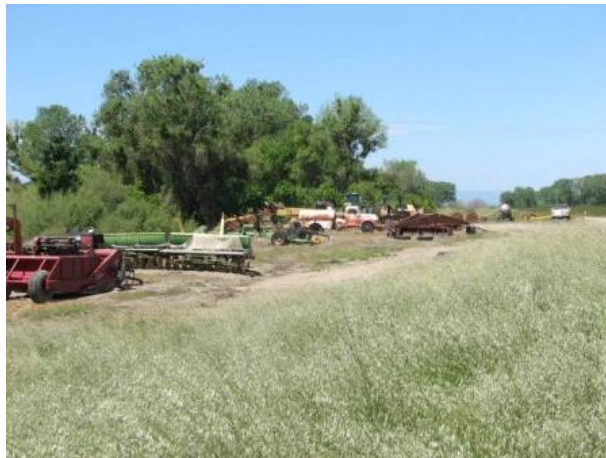
johngw\_f\_20110923\_413.jpg

Levee Mile Report Line	55
Start Levee Mile	15.94
End Levee Mile	15.94
Location	Water Side
Category	Earthen Levee
Item	Encroachments

Farm equipment has been parked on the waterside berm.

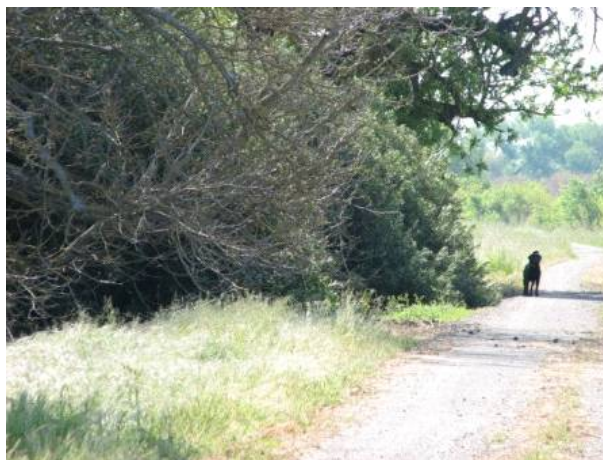
johngw\_f\_20110923\_414.jpg

Landscape shrubs, photo taken in spring 2010.

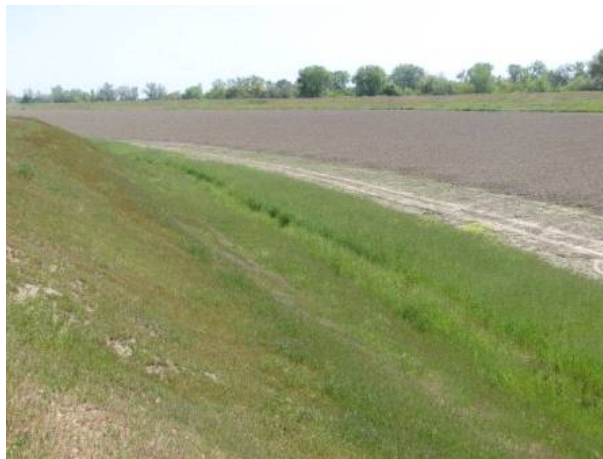
johngw\_f\_20110923\_438.jpg

Levee Mile Report Line	57
Start Levee Mile	16.86
End Levee Mile	17.45
Location	Land Side
Category	Earthen Levee
Item	Encroachments

Agricultural ditch, photo taken in spring 2010.

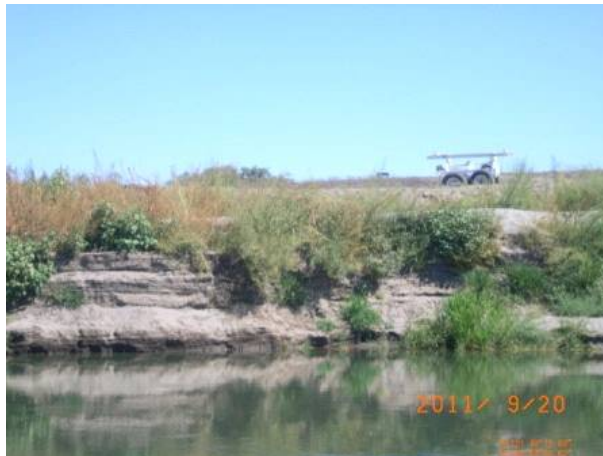
USACE 2011 Photo #1

LMR No.	Levee Mile		Category	Item	Location *	Rating **	Action/Comment	GPS Latitude/Longitude		Issue No.
	Start	End						Start	End	
58	18.40	18.41	Supplemental	USACE Erosion Survey	WS	M	Inspector Comments: 2006 - Eddy flow and overtopping flow collide on the inside of a tight bend. Scour caused by converging flows created large scallop on the inside of a bend. 2007 - Site still looks bad. Would be a good candidate for a setback levee. 2008 - Some new deposition of sand on eddy bar. 2009 - Much of the site has filled in with sand deposition. Continuing to heal. 2010 - New deposition. 2011: There has been some deposition as well as erosion since last year. [2011 Site ID: SAC_103-4_L]	38.901199 ° -121.803225 °	38.900993 ° -121.803382 °	41 Y
59	18.50	18.50	Earthen Levee	Erosion / Bank Caving	WS	W	Note and monitor erosion site.	38.900873 ° -121.802680 °	38.900873 ° -121.802680 °	51 Y
60	18.51	18.51	Supplemental	USACE Erosion Survey	WS	M	Inspector Comments: 1997 - Pocket failures of cobble revetment toe; scallops of rock loss along the bank; irregular bankline developing. 2001 - Small scallops in the toe of the berm. 2005 - Still multiple erosion pockets in the toe. 2006 - Two new small slumps. 2011: Old cobble continue to fail causing minor slumping. [2011 Site ID: SAC_104-0_L]	38.901337 ° -121.801175 °	38.902721 ° -121.790677 °	43 Y

Levee Mile Report Line	58
Start Levee Mile	18.40
End Levee Mile	18.41
Location	Water Side
Category	Supplemental
Item	USACE Erosion Survey

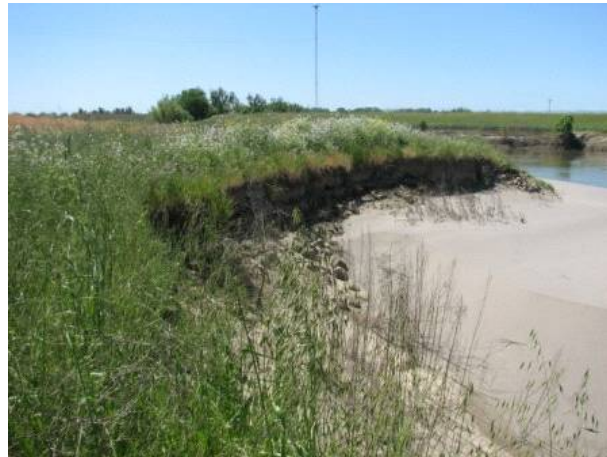
johngw\_f\_20110923\_428.jpg

Levee Mile Report Line	59
Start Levee Mile	18.50
End Levee Mile	18.50
Location	Water Side
Category	Earthen Levee
Item	Erosion / Bank Caving

This is an inside curve in the river and erosion has occurred.

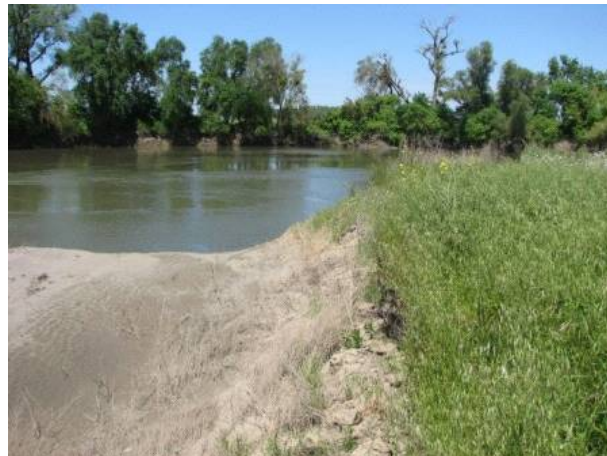
johngw\_f\_20110923\_429.jpg

Levee Mile Report Line	59
Start Levee Mile	18.50
End Levee Mile	18.50
Location	Water Side
Category	Earthen Levee
Item	Erosion / Bank Caving

This is an upstream view of the same erosion.

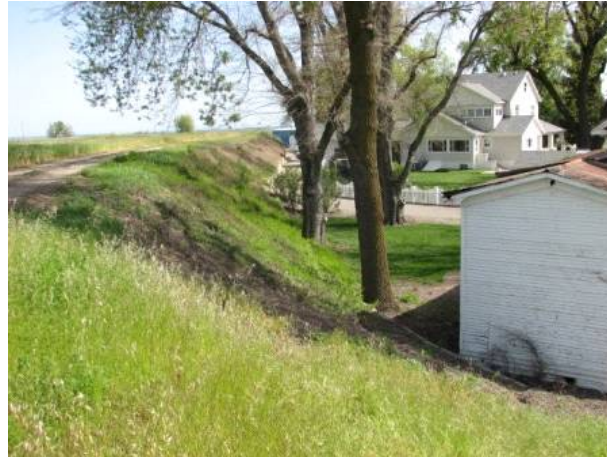
Levee Mile Report Line	61
Start Levee Mile	19.19
End Levee Mile	19.19
Location	Land Side
Category	Earthen Levee
Item	Encroachments
Building and wall into levee with landscape, photo taken in spring 2010.	
johngw_f_20110923_416.jpg

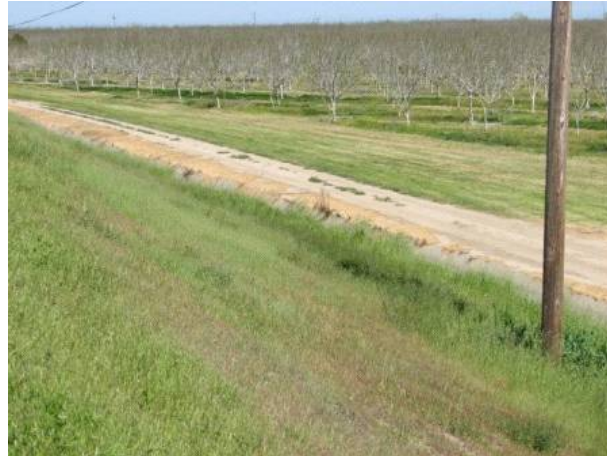
Levee Mile Report Line	64
Start Levee Mile	20.86
End Levee Mile	21.40
Location	Land Side
Category	Earthen Levee
Item	Encroachments
Agricultural ditch, photo taken in spring 2010.	
johngw_f_20110923_439.jpg

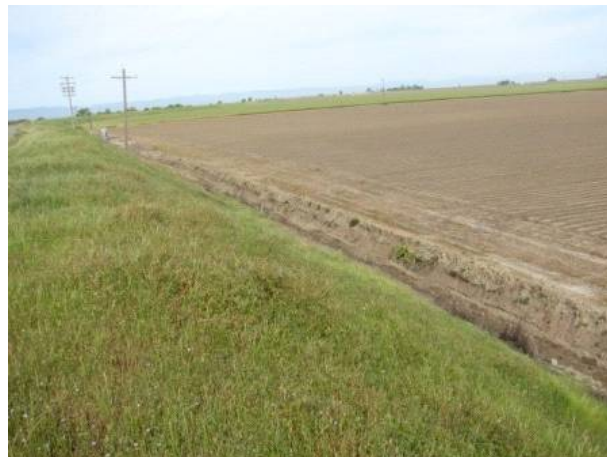
Levee Mile Report Line	67
Start Levee Mile	21.69
End Levee Mile	21.91
Location	Land Side
Category	Earthen Levee
Item	Encroachments
The agricultural ditch runs along the toe of the levee.	
johngw_f_20110923_434.jpg

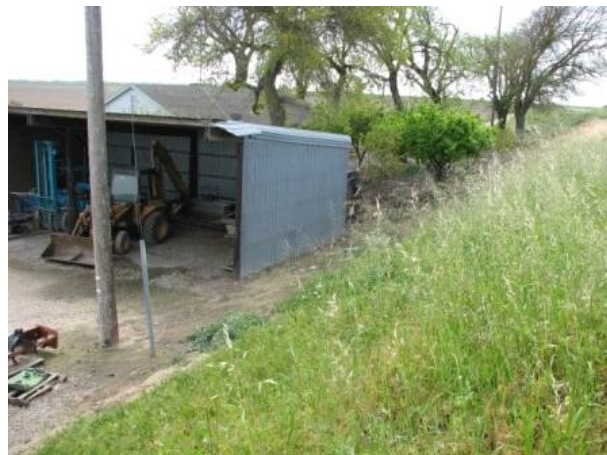
Levee Mile Report Line	68
Start Levee Mile	24.04
End Levee Mile	24.04
Location	Land Side
Category	Earthen Levee
Item	Encroachments
Pole barn and some equipment, photo taken in spring 2010.	
johngw_f_20110923_420.jpg

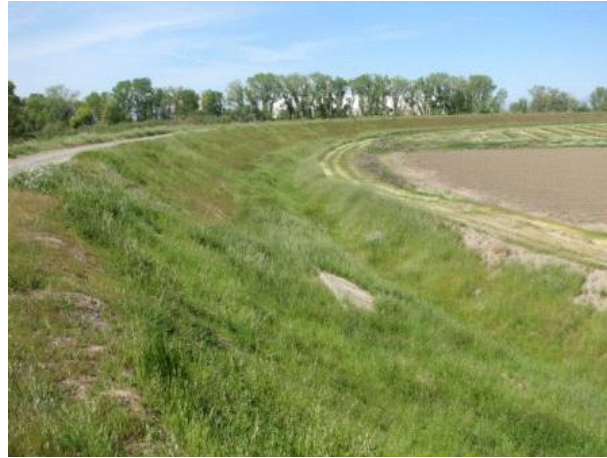
johngw\_f\_20110923\_440.jpg

Agricultural ditch, photo taken in spring 2010.

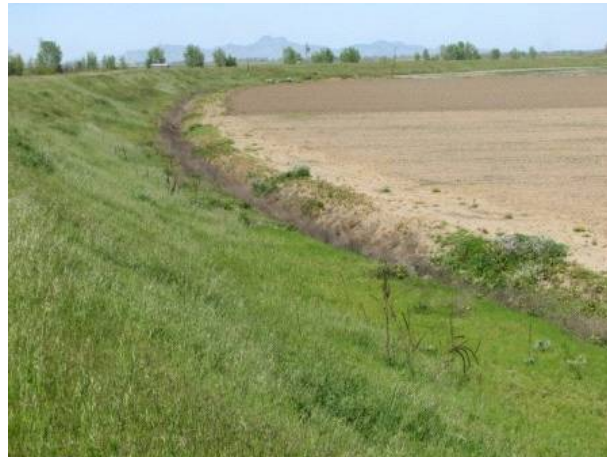
johngw\_f\_20110923\_441.jpg

Levee Mile Report Line	72
Start Levee Mile	25.76
End Levee Mile	26.54
Location	Land Side
Category	Earthen Levee
Item	Encroachments

Agricultural ditch, photo taken in spring 2010.

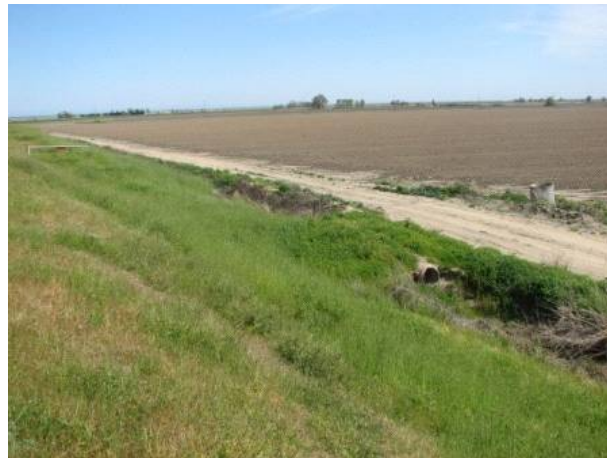
johngw\_f\_20110923\_442.jpg

Levee Mile Report Line	73
Start Levee Mile	26.84
End Levee Mile	27.07
Location	Land Side
Category	Earthen Levee
Item	Encroachments

Agricultural ditch, photo taken in spring 2010.

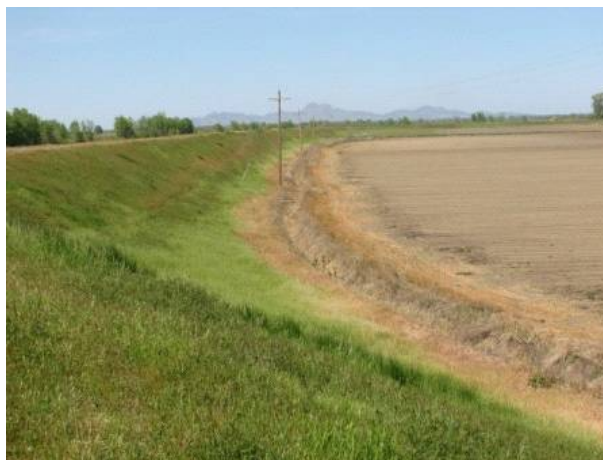
johngw\_f\_20110923\_443.jpg

Agricultural ditch, photo taken in spring 2010.

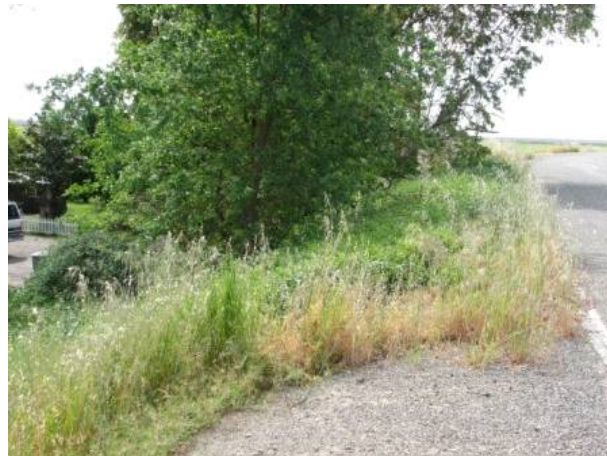
johngw\_f\_20110923\_423.jpg

Levee Mile Report Line	79
Start Levee Mile	30.60
End Levee Mile	30.60
Location	Land Side
Category	Earthen Levee
Item	Encroachments

The groundcover in the landscape makes it hard to see the levee slope.

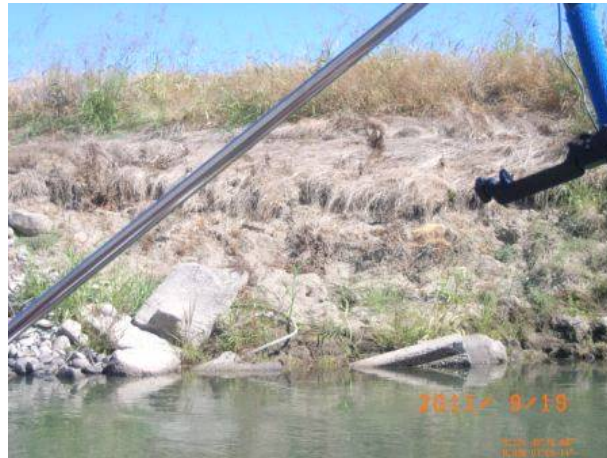
USACE 2011 Photo #1

LMR No.	Levee Mile		Category	Item	Location *	Rating **	Action/Comment	GPS Latitude/Longitude		Issue No.
	Start	End						Start	End	
81	30.91	30.91	Supplemental	USACE Erosion Survey	WS	M	Inspector Comments: 2000 - Eroding, vertical berm slope over a vertical cohesive toe; slow erosion but getting close to the toe. 2002 - Erosion is getting close to the levee, still eroding with some new small slumps. 2004 - Some minor new erosion. 2006 - Some new erosion, cleaned off older scars and slump faces. 2008 - New, small, partial rotational failure. 2011: Some new minor erosion. [2011 Site ID: SAC_116-0_L]	38.999745 ° -121.800898 °	39.001413 ° -121.802889 °	66 Y
82	32.71	33.00	Earthen Levee	Encroachments	LS	PO	Agricultural Ditch	39.012142 ° -121.825770 °	39.015585 ° -121.823442 °	60 Y
83	33.33	33.33	Earthen Levee	Encroachments	LS	PO	Buildings	39.019722 ° -121.820345 °	39.019722 ° -121.820345 °	46 Y
84	33.41	33.41	Earthen Levee	Encroachments	WS	PO	Buildings Inspector Comments: Pumping Plant Intake structure	39.020875 ° -121.820273 °	39.020875 ° -121.820273 °	48 Y

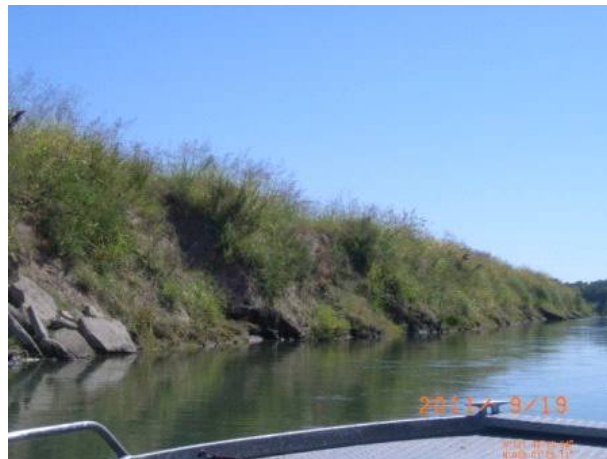
USACE 2011 Photo #2

Levee Mile Report Line	81
Start Levee Mile	30.91
End Levee Mile	30.91
Location	Water Side
Category	Supplemental
Item	USACE Erosion Survey

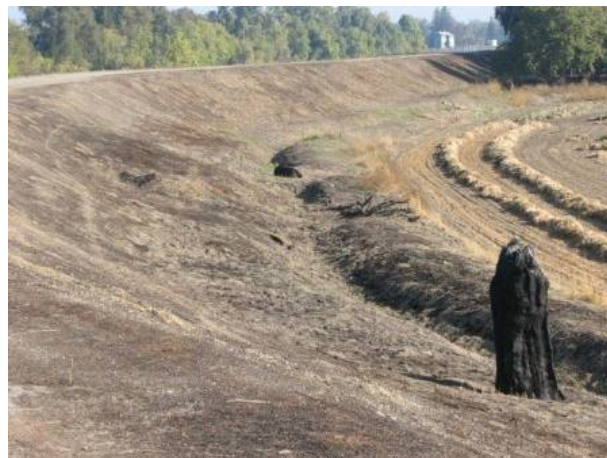
johngw\_f\_20110923\_435.jpg

Levee Mile Report Line	82
Start Levee Mile	32.71
End Levee Mile	33.00
Location	Land Side
Category	Earthen Levee
Item	Encroachments

Older, unused agricultural ditch. Tree stump needs to be removed.
